## DETAIL: Modified Bitumen (Mod Bit) Low Slope Roof

### GENERAL DETAILS – AC SUPPORT STANCHIONS – ROOF COATING RESTORATION

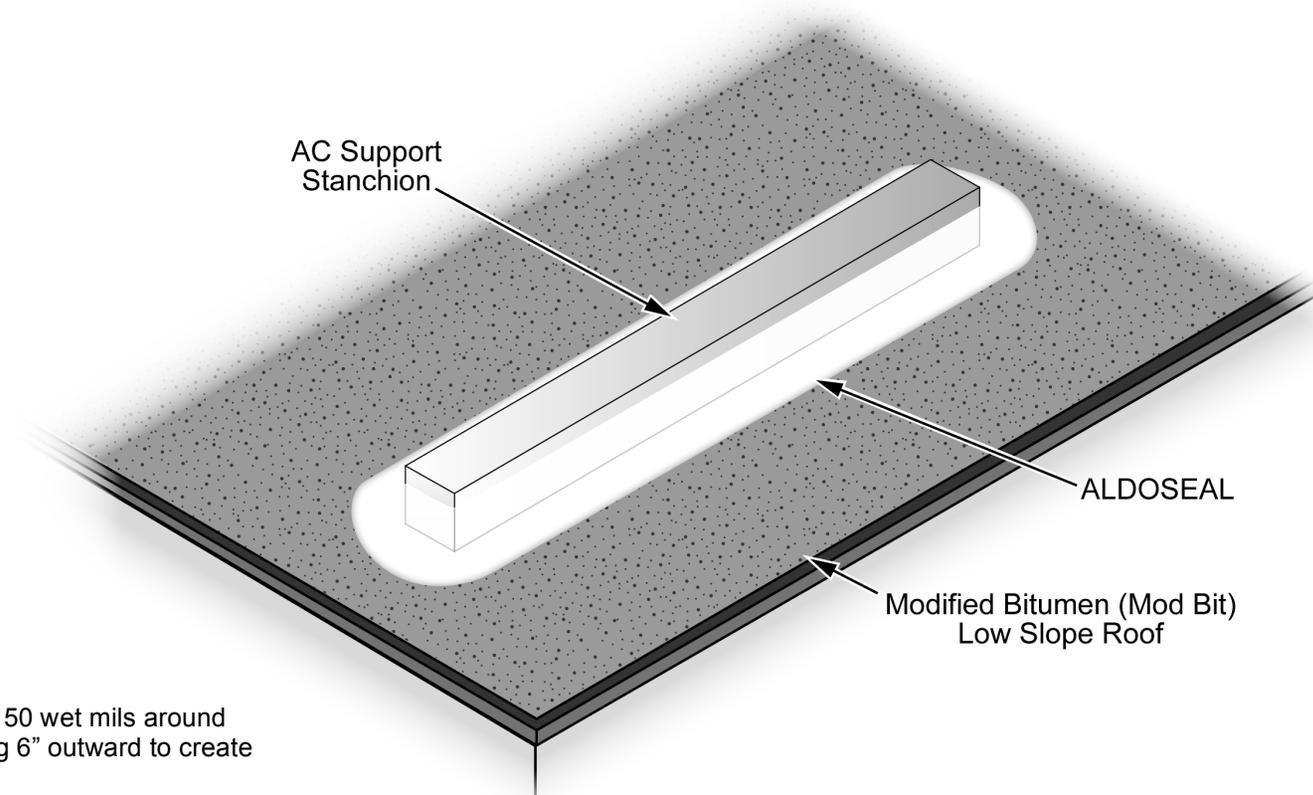
1. Apply a minimum of 50 wet mils around stanchion, feathering 6" outward to create positive drainage.
2. Ensure all voids between stanchion and roof membrane are completely filled.

Note: Support stand must have remaining service. If deteriorated, it must be replaced and membrane repaired prior to ALDOSEAL application.

Option: If required by specification, ALDOSEAL fabric is used in a three course application method with ALDOSEAL product of choice. Contact Aldo Products Company, Inc., for assistance.
