DETAIL: TPO Low Slope Roof

GENERAL DETAILS – PIPE PENETRATION – ROOF COATING RESTORATION

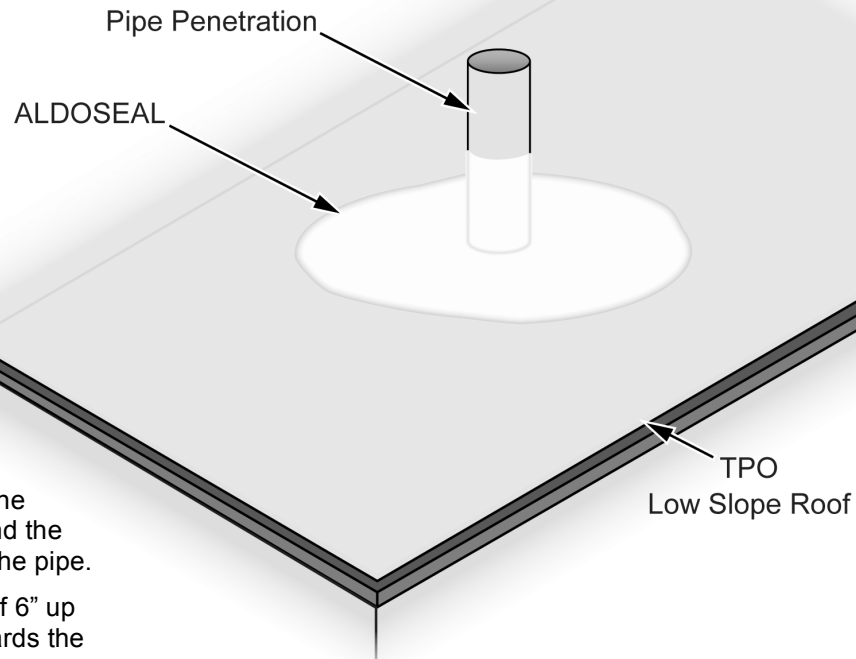
1. Apply a minimum of 50 wet mils of the ALDOSEAL product of choice around the base of pipe, extending 8-12" from the pipe.
2. Apply material up pipe a minimum of 6" up the pipe, feathering application towards the top of the pipe.
3. Make sure all voids are filled.
