## DETAIL: Metal Roof – Standing Seam

### GENERAL DETAILS – FIBERGLASS SKYLIGHT PANEL– ROOF COATING RESTORATION

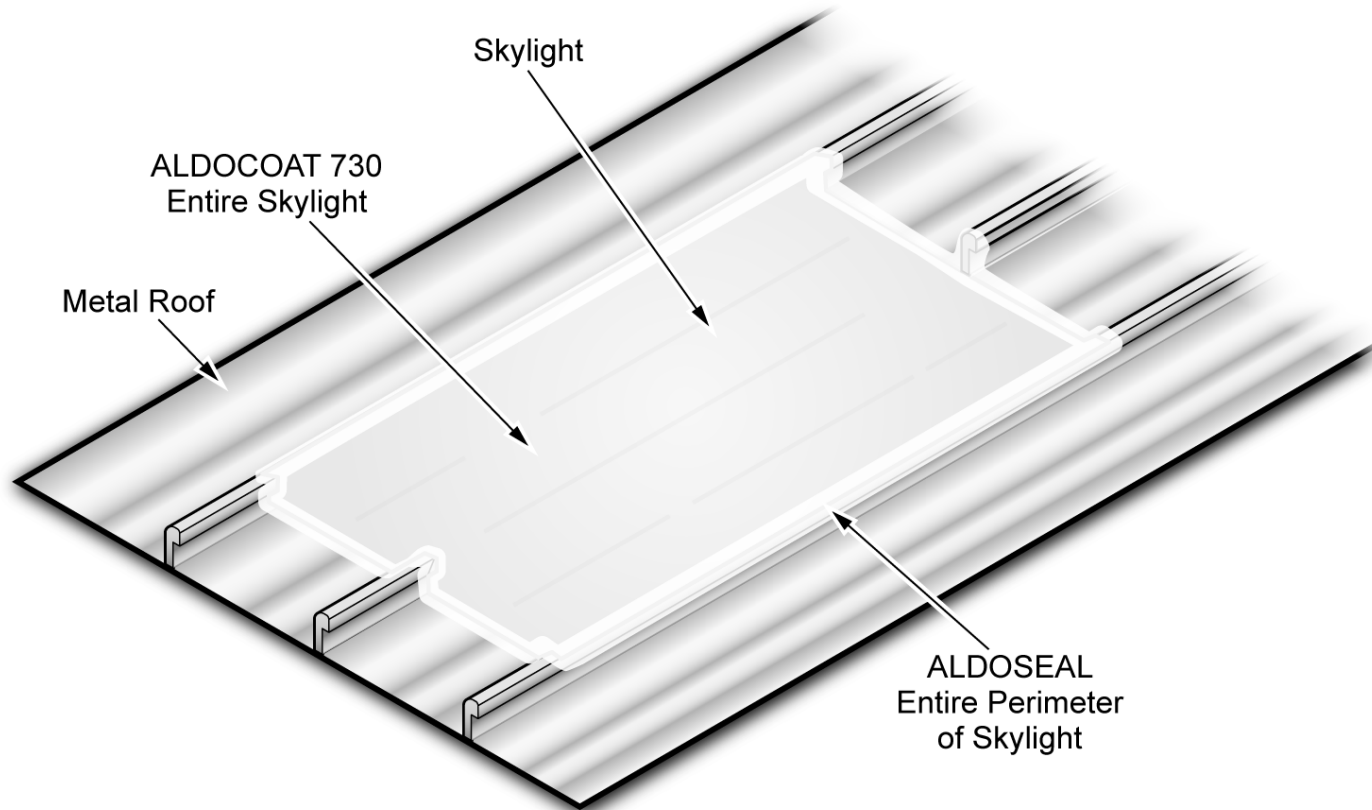
1. Apply ALDOCOAT 730 Skylight to entire skylight surface area at a minimum of 16 wet mils.
2. Apply ALDOSEAL sealant to skylight perimeter, at a minimum of 50 wet mils.
3. Feather sealant to maintain positive drainage around skylight perimeter.
