DETAIL: Modified Bitumen (Mod Bit) Low Slope Roof

GENERAL DETAILS – DRAIN – ROOF COATING RESTORATION

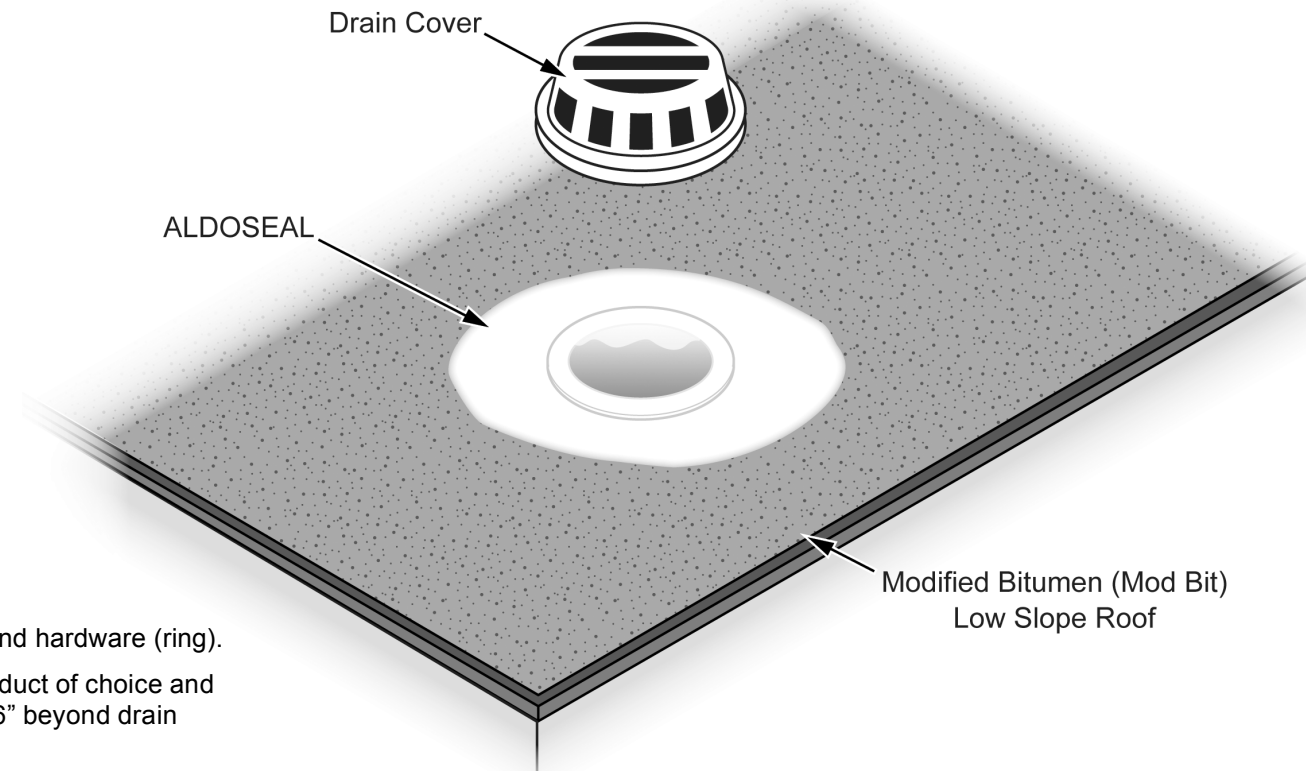
1. Remove drain cover and hardware (ring).
2. Apply ALDOSEAL product of choice and extend a minimum of 6" beyond drain perimeter.
3. Application to be feathered to maintain positive water drainage.
4. Re-install ring, hardware and drain cover.

Option: If required by specification, ALDOSEAL fabric is used in a three course application method with ALDOSEAL product of choice. Contact Aldo Products Company, Inc., for assistance.
