## DETAIL: Metal Roof – Standing Seam

### GENERAL DETAILS – RAISED SKYLIGHT VERTICAL SEAM – ROOF COATING RESTORATION

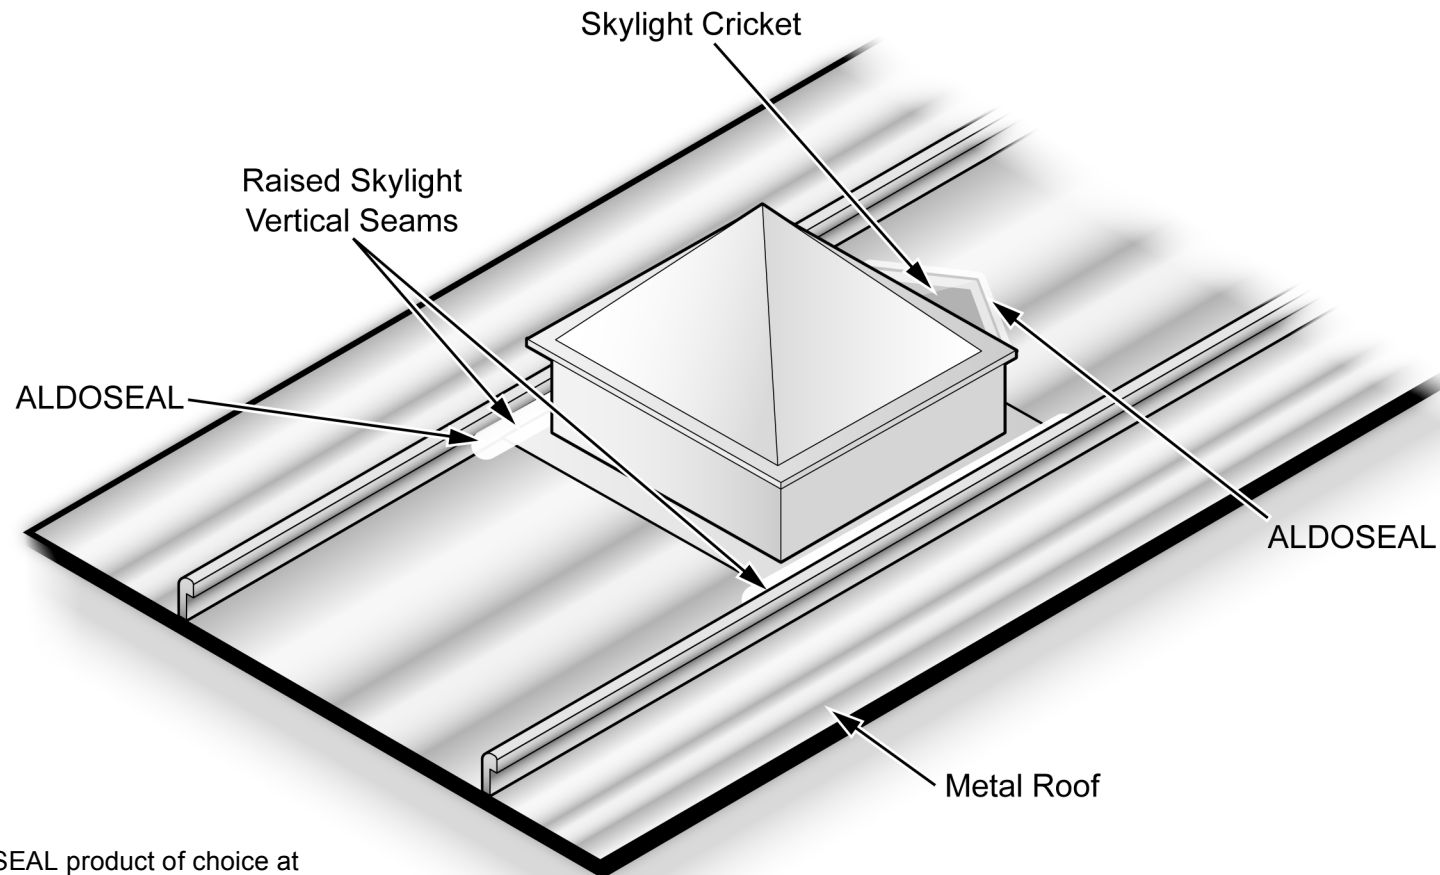
1. Apply the ALDOSEAL product of choice at 4" centered and parallel to the vertical seam
2. Apply at a rate of approximately 50 wet mils, ensuring all voids are sealed.
3. The ALDOSEAL product is to be applied and feathered to create positive drainage of any water flow.
